Steve Corrigan  
Your New Home Inspector

# SAMPLE REPORT - POST COMPLETION INSPECTION

Monday, 03 July 2023

147 Issues Identified

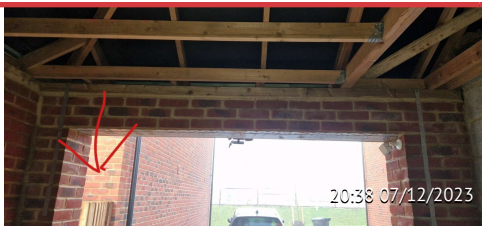
### ISSUE 7

16mm deviation in brick work wall on RHS of the car Port.

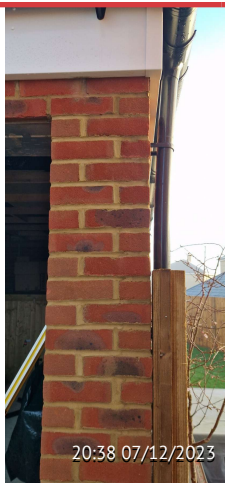
### ISSUE 11

Damaged brick RHS next to the gate post. Repair required.

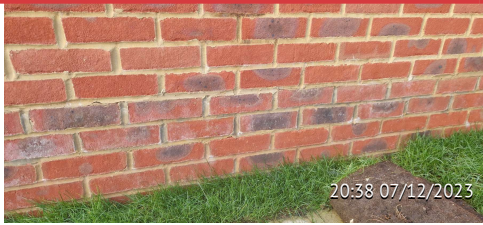
### ISSUE 13

Redundant fixing hole to be repaired to prevent rain water ingress.

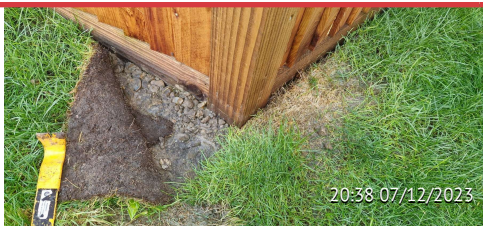
### ISSUE 17

Damaged fence panel. Replacement required.

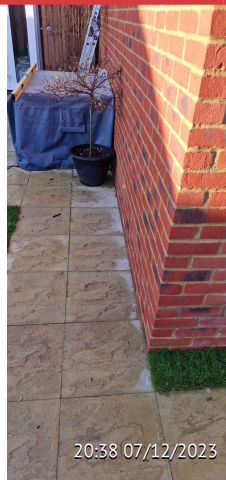
### ISSUE 21

Slabs along car Port Wall are not level. 11mm belly. Customer has advised that standing water occurs in this area.

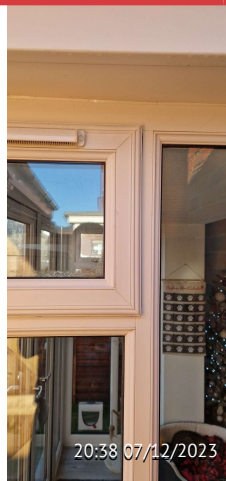
### ISSUE 30

Assigned To Rear Facade  
Sealant incomplete.

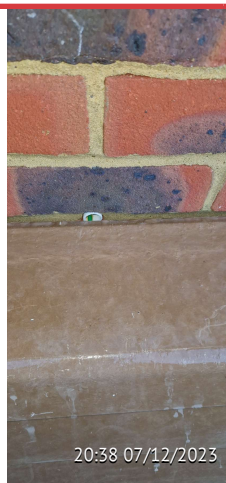
#### **ISSUE 44**

Fake weep vent found above electrical intake housing. Developer to carry out a full review of weep vents on the property and QA documentation to be provided on the correct installation of weep vent to the property.

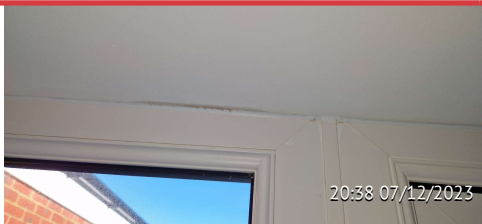
#### ISSUE 51

LHS - beading damaged through condensation. Replacement required.

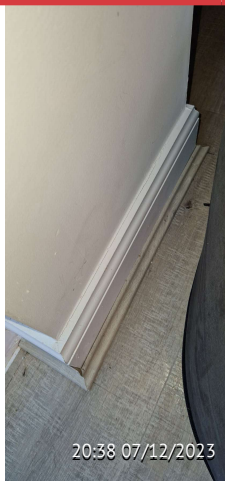
#### **ISSUE 56**

RHS at low level sealant has failed and beading to floor is damaged.

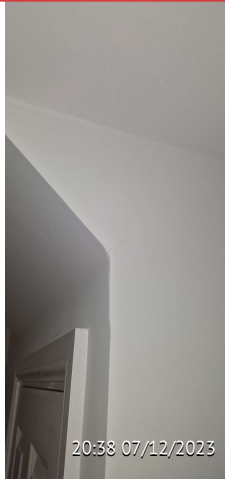
#### **ISSUE 58**

Hair line cracking to wall to ceiling junction on rear wall.

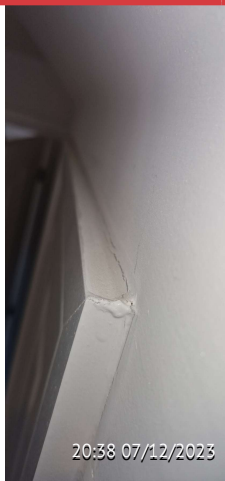
#### **ISSUE 59**

Hair line cracking above door to under stair cupboard

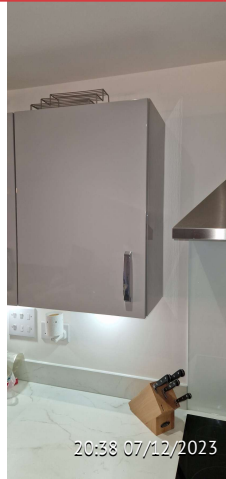
### ISSUE 64

Screw caps missing.

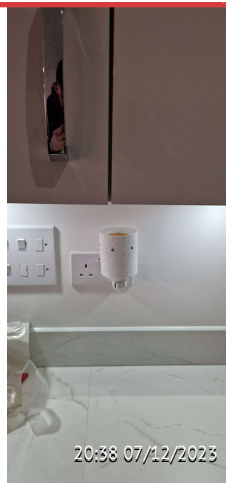
### ISSUE 65

Soft close hinges not working to the wall unit left of the extract. Replacement required.

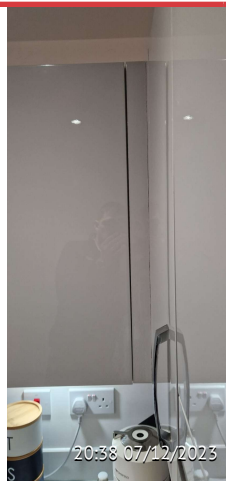
### ISSUE 66

Door alignment to be improved throughout the kitchen. Full review and alignment required.

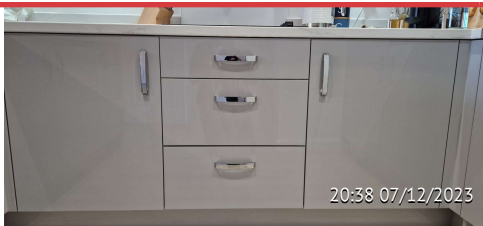
#### **ISSUE 68**

Mastic seal required to corner.

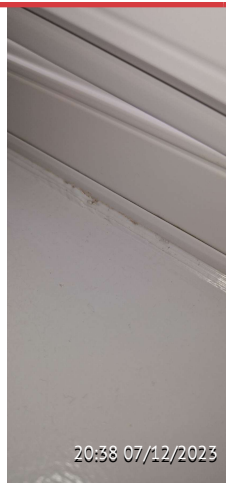
### ISSUE 87

Top of architrave poorly decorated, improvement required.

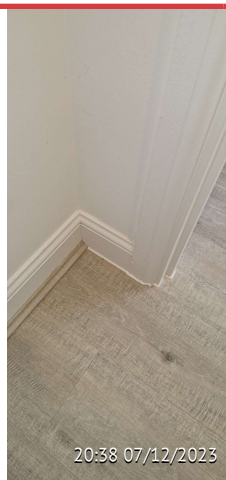
### ISSUE 97

Joint in beading when the room is only 1600mm long. Beading should be replaced by 1 section to eliminate a joint that should not be present.

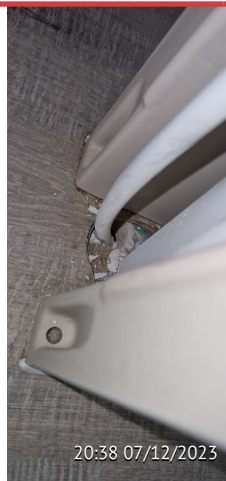
### ISSUE 133

No timber spreader under central leg of the bath. Timber spreader required to speed the load from the path into the joists below.

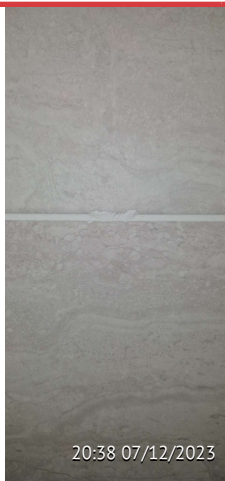
### **ISSUE 136**

Hole in grout to be repaired.

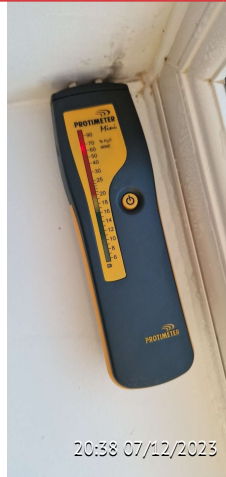
### ISSUE 143

L01 living Room- right side window. LHS LL reading 65

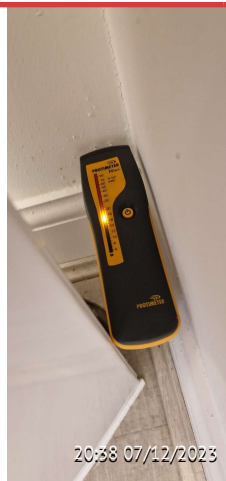
#### ISSUE 144

L01 Bedroom- right window LHS LL Reading 65

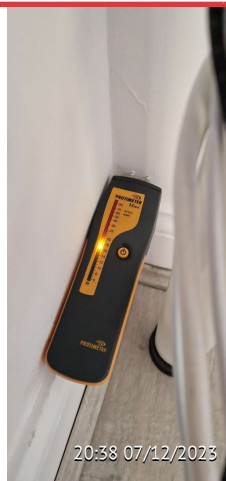
#### ISSUE 145

GF WC - behind basin pedestal on outside wall reading 16

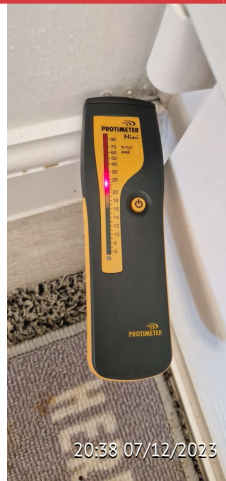
#### ISSUE 146

GF study - front left corner above skirting reading 16
