# THERMAL IMAGING SURVEY

**YOUR NEW HOME INSPECTOR**

Sample Report

This report is to identify potential thermal loss issues to my client of their recently purchased brand new property. The internal temperature of the property was 20 degrees with an outside temperature of 6 degrees at the time of the survey.

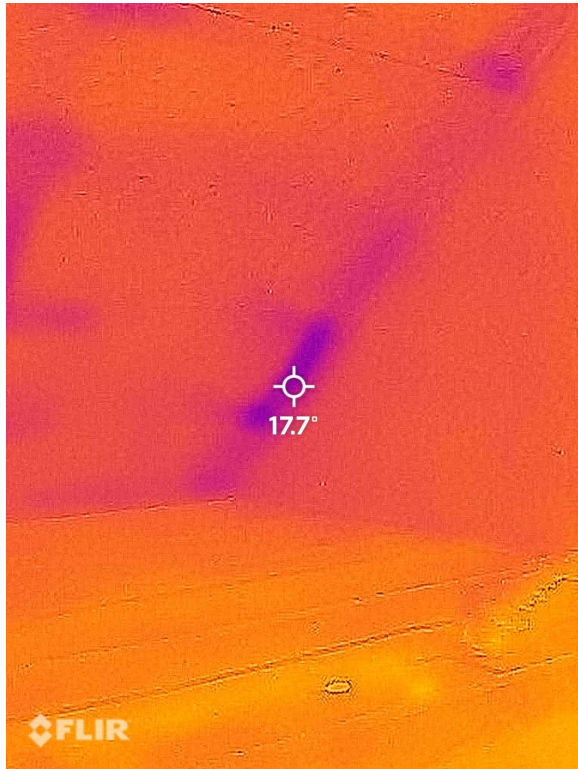
**Image 1**

Rear Elevation Roof – No concerns. The space seems to hold the heat very well. No action required.

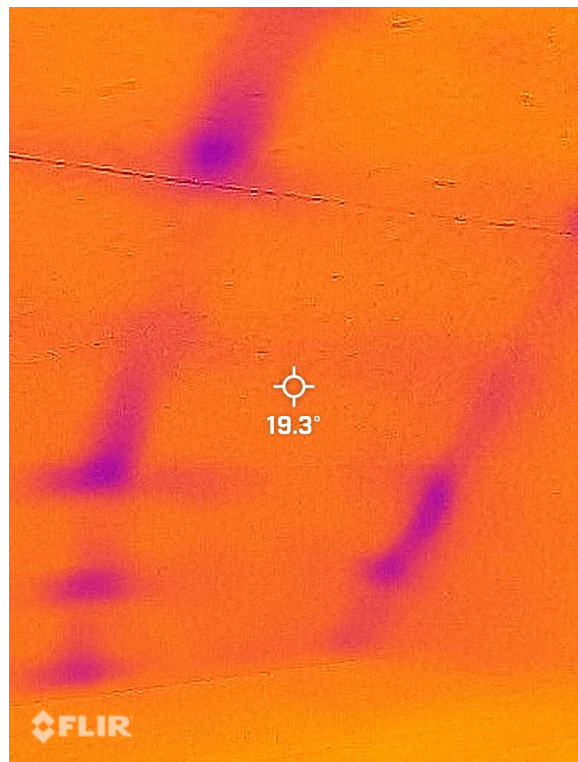
**Image 2**

Front Elevation Roof – No concerns. The space seem to hold the heat very well. No action required.

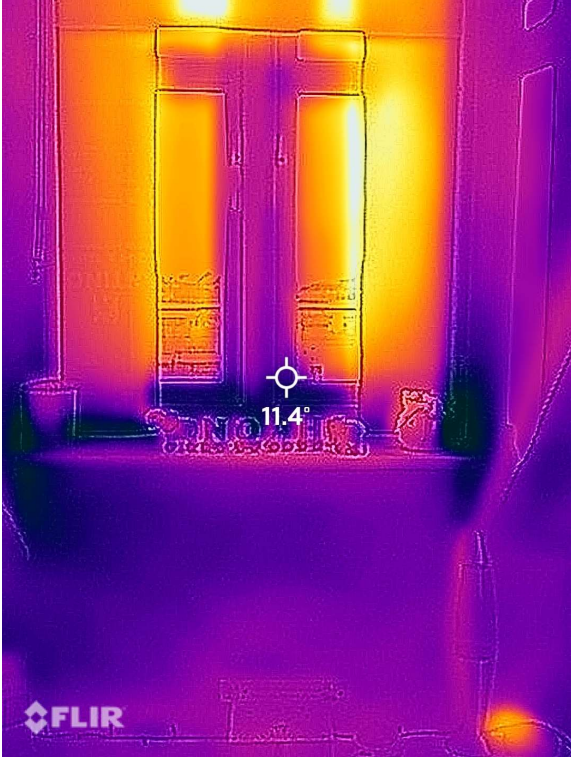
<p>A thermal image of a window in a room. The window is the central feature, showing a bright yellow/orange area indicating heat loss. The surrounding walls and floor are in shades of purple and blue, indicating lower temperatures. A temperature reading of 11.4° is visible on the image. The FLIR logo is in the bottom left corner.</p>	<p><b>Image 3</b></p> <p>Left Window – Concerns at low level. Imaging shows heat loss at low level within the window make up and to both sides of the building fabric. Further investigation required.</p>

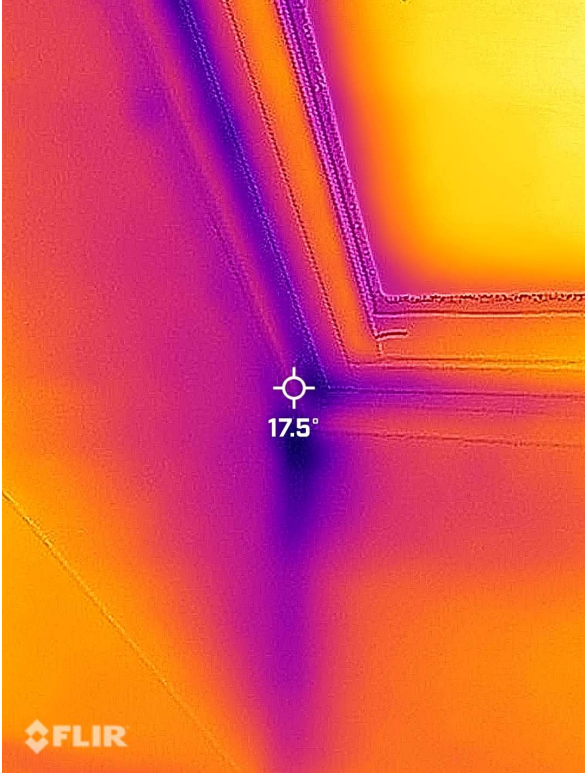
<p>A thermal image of a window, likely a Velux skylight, showing heat loss at the junction of the window and the opening. The junction area is bright yellow/orange, while the surrounding areas are in shades of purple and blue. A temperature reading of 17.5° is visible on the image. The FLIR logo is in the bottom left corner.</p>	<p><b>Image 4</b></p> <p>Right Window (Velux) LHS – Concerns each side of the window at low level. Heat loss seems to be at the junction of the window and the opening. Further investigation required.</p>

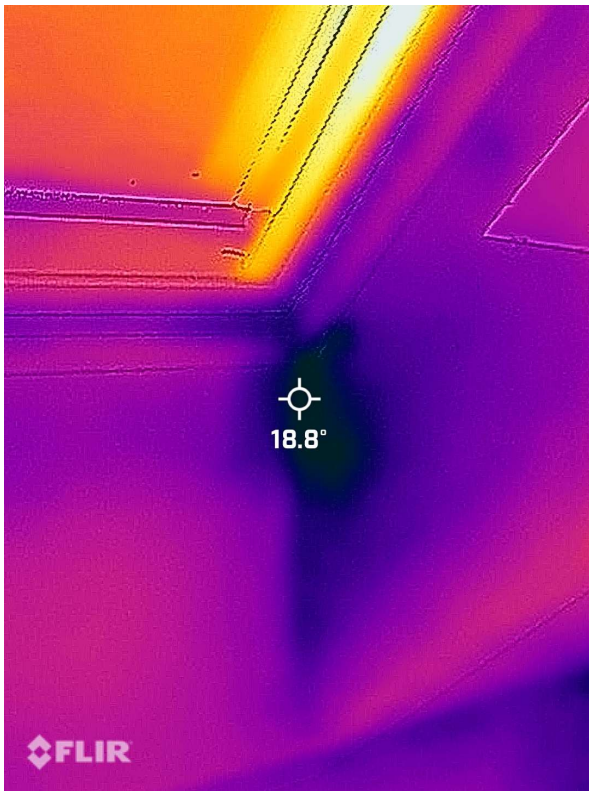
**Image 5**

Right window (Velux) – RHS – Concerns each side of the window at low level. Heat Loss seems to be through the building fabric below the window itself.

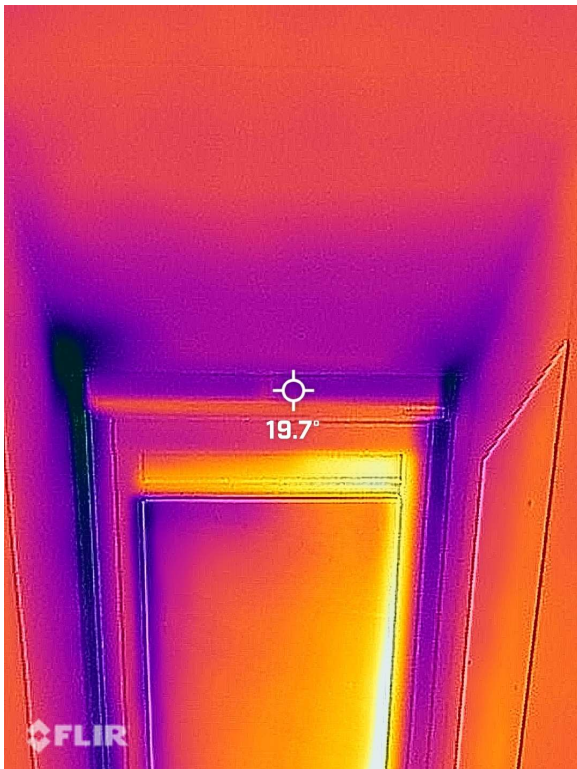
**Image 6**

Right window (Velux) – Concerns at the top of the window on both sides. Heat loss seems to be at the junction of the window and the opening. Further investigation required.

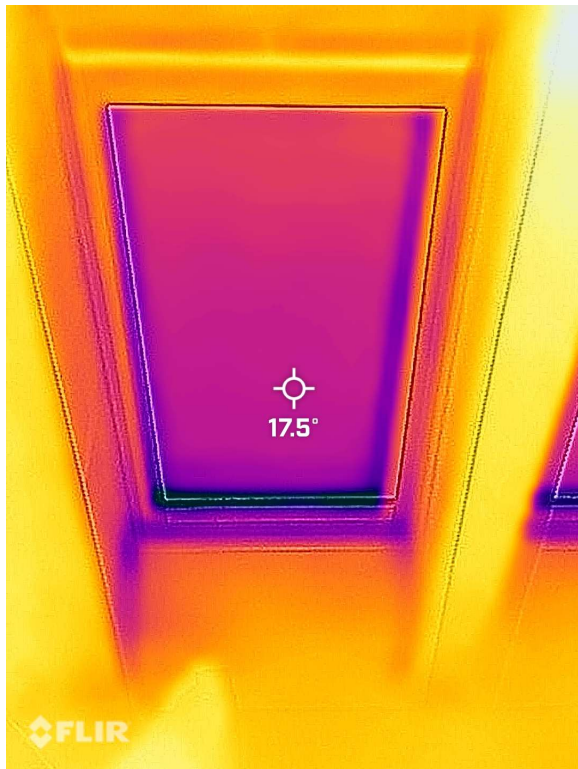
**Image 7**

Left Window – concerns at the bottom of the window. Heat loss seems to be from the window not sealing tight enough to the frame. Further investigation required.

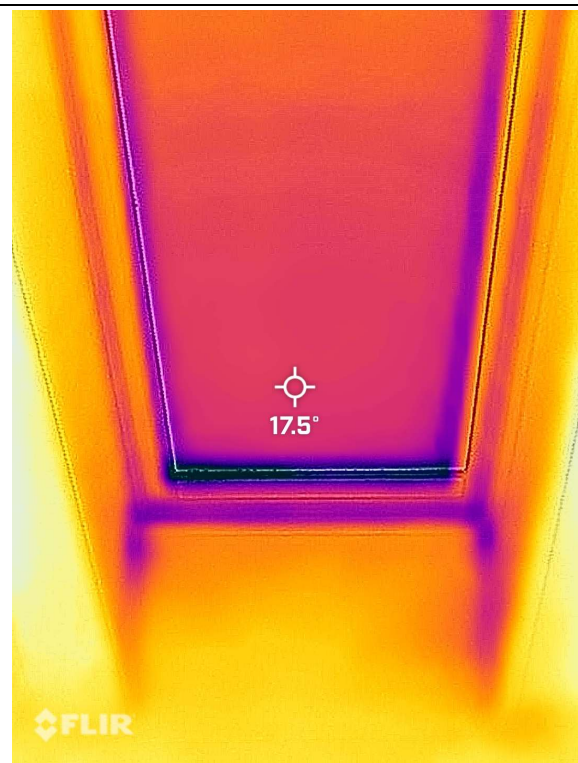
**Image 8**

Right Window – concerns at the bottom of the window. Heat loss seems to be from the window not sealing tight enough to the frame. Further investigation required.

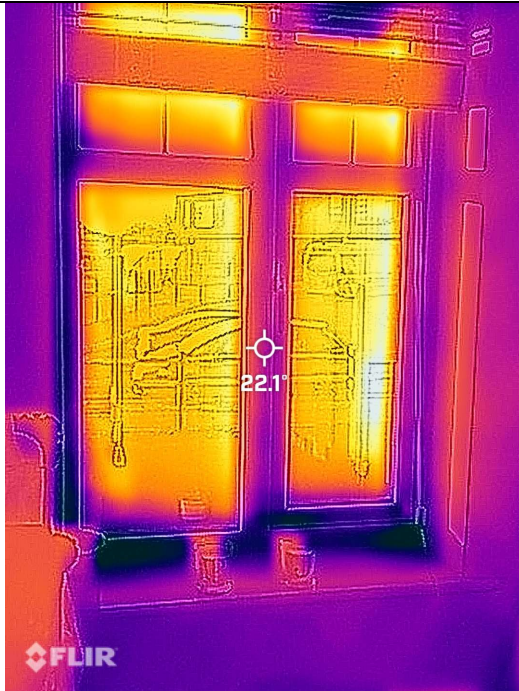
**Image 9**

Left window – Concerns for heat loss on the LHS and the bottom of the window. Further investigation required.

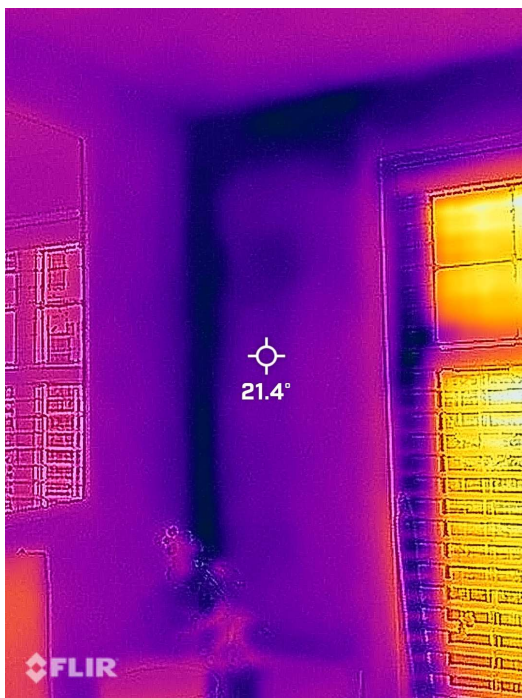
**Image 10**

Concerns that the party wall lining at the front of the building seems to be losing heat. Further investigation required.

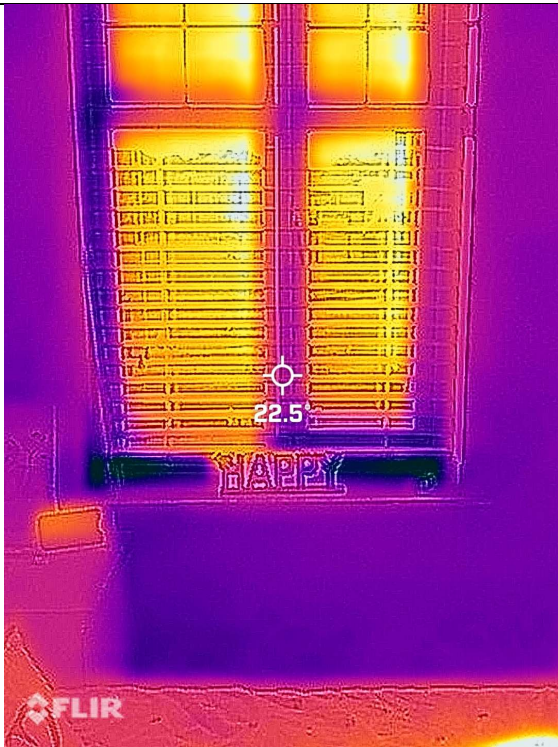
**Image 11**

Right Window – Concerns of heat loss at the bottom of the window. Potentially the openable windows are not sealing tight to frame when shut. Further investigation required.

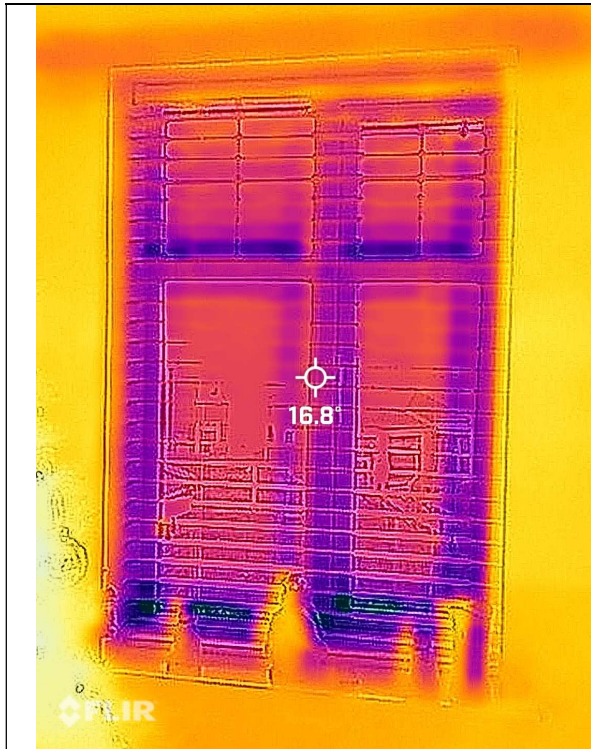
**Image 12**

Right window. Concerns of excessive heat loss at the bottom of the window. Potentially the windows are not sealed against the frame tight enough. Further investigation required.

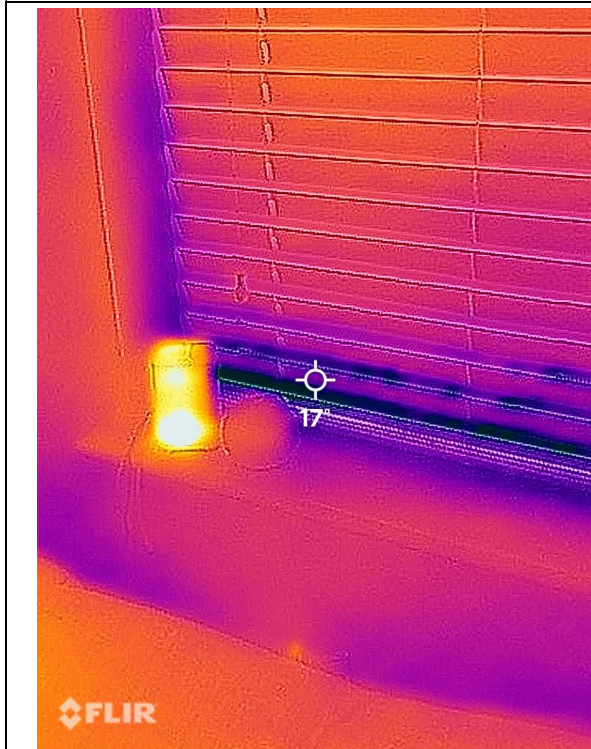
**Image 13**

Left Window - Concerns of excessive heat loss at the bottom of the window. Potentially the windows are not sealed against the frame tight enough. Further investigation required.

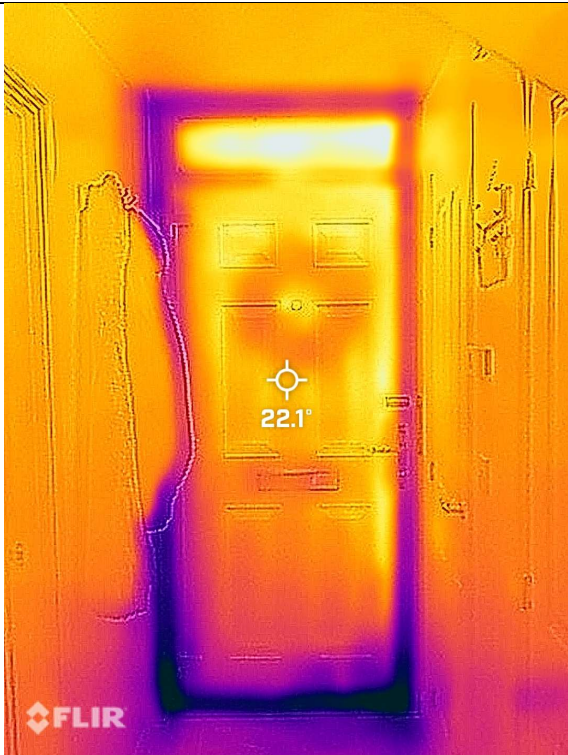
**Image 14**

Front door – concerns of excessive heat loss at the bottom of the door and on both side at low level. Potentially the door is out of plumb creating an insufficient seal where identified. Further investigation required.

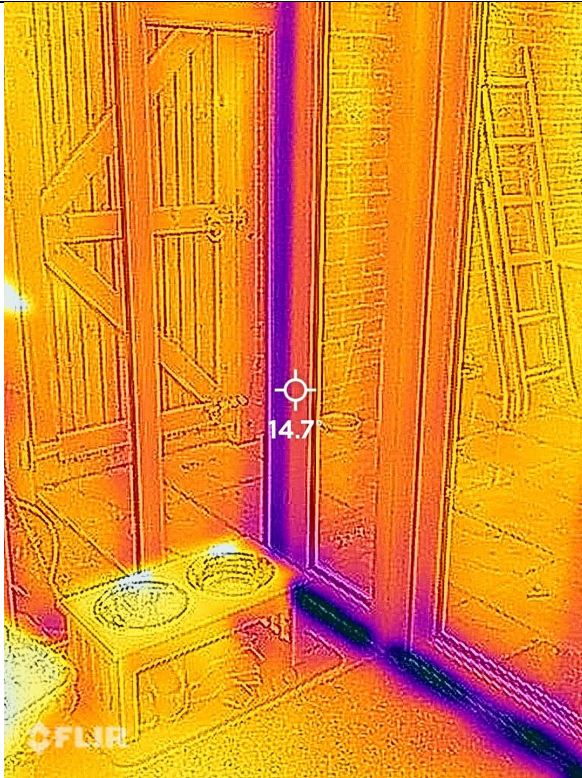
**Image 15**

Rear conservatory LHS – concerns of heat loss at the low-level junction to the floor and vertically up the corner post. Further investigation required.

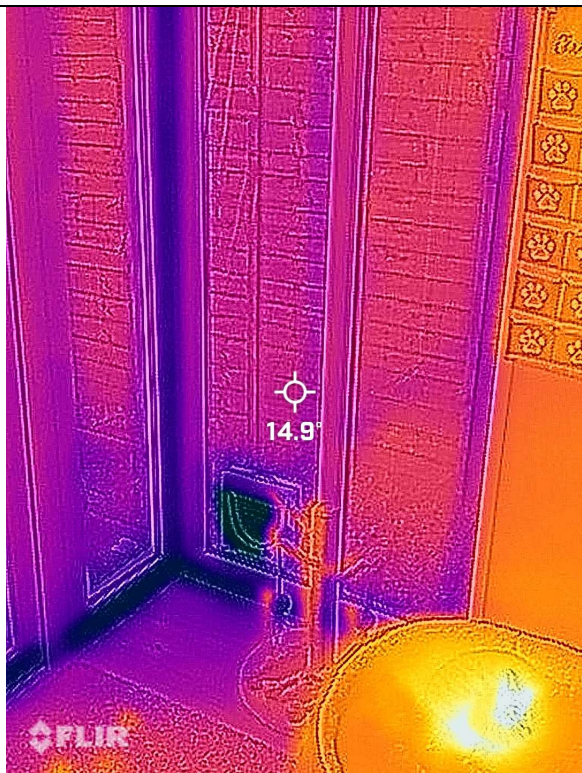
**Image 16**

Rear conservatory RHS - concerns of heat loss at the low-level junction to the floor and vertically up the corner post. Further investigation required.
