Steve Corrigan  
Your New Home Inspector

# SAMPLE REPORT - POST COMPLETION INSPECTION

Monday, 03 July 2023

147 Issues Identified

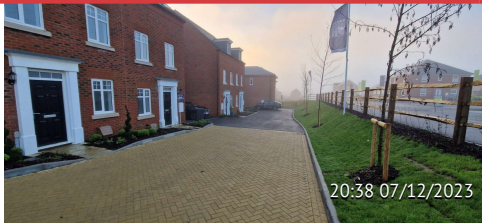
Very good presentation on approach to the property.  
Good finish to roads and landscape areas.

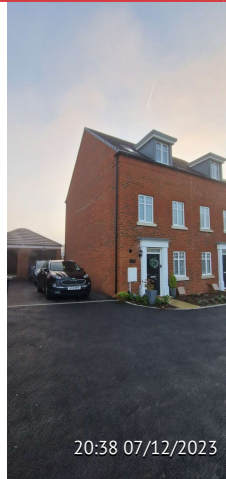
Good presentation of property. Clean and tidy.

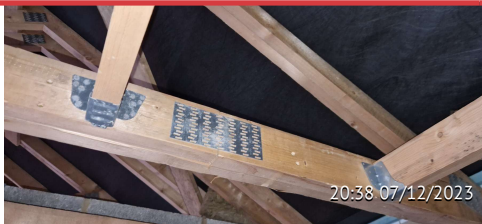
## ISSUE 1

DWH to review splice plate on roof truss with manufacture. Good practise is to splice with the same size timbers of the truss.

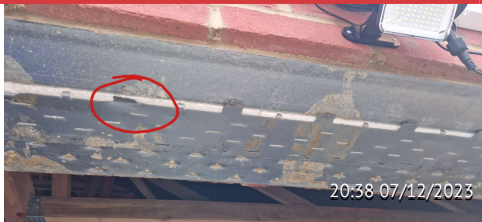
### ISSUE 4

General clean of underside of lintel required. Central plate fixings have failed. This will require replacing.

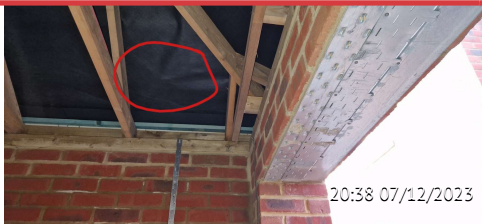
### ISSUE 9

There seems to be an object between the roofing system that is adding pressure onto the roof membrane. This will need intrusive work to understand the potential issue.

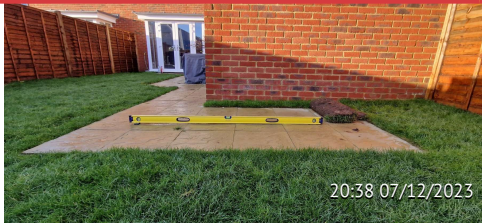
### ISSUE 19

Gaps in turf. New turf required and better abutment needed.

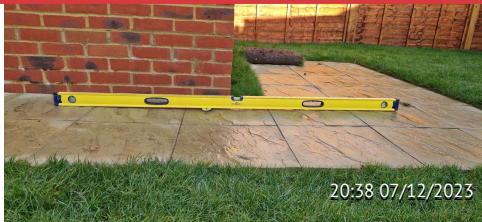
### ISSUE 20

Paving slabs to rear of car Port 15mm out of level.

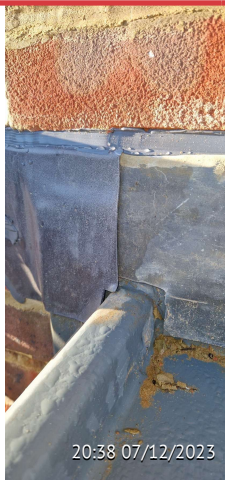
#### ISSUE 25

Building debris to be cleaned from roof.

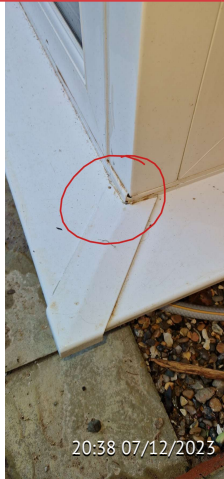
### ISSUE 32

Assigned To Rear Facade  
Excessive glue to be removed from window frames at low level

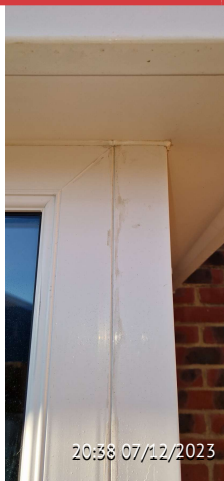
### ISSUE 33

RHS mitre has split just above sill.

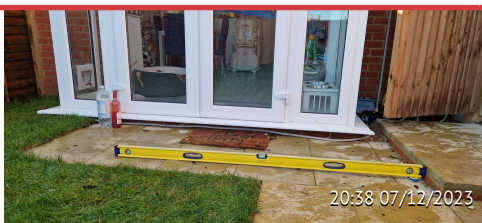
### ISSUE 35

Paving not level by 21mm away from the property

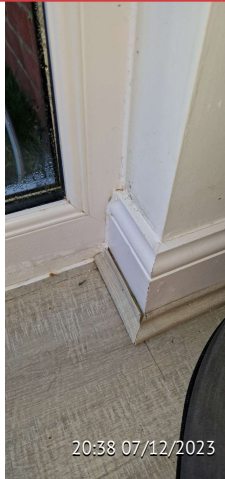
#### ISSUE 55

Incomplete sealant to RHS cover at low level. General improvement required to this area.

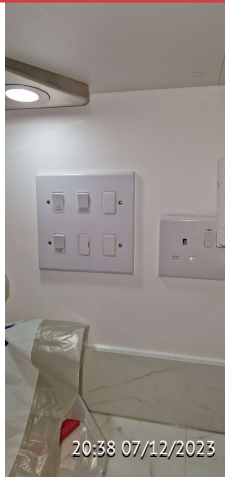
### ISSUE 63

Gap between extract hood and splash back. Detail needs to be reviewed by the developer, and a proposal should be submitted to the owner on the close out. My suggestion is that the extract is lowered to meet the top of the splash back.

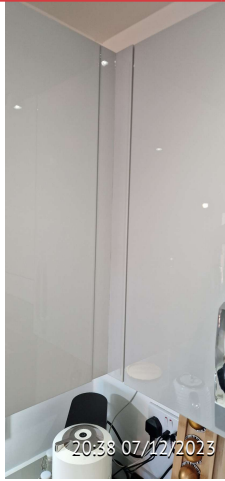
### ISSUE 67

Door alignment to be Improved.

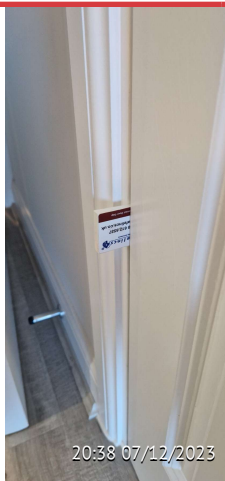
#### ISSUE 75

Door hinge screw are not from the hinge manufacturer. Spax screws used into frame. Standard test data from the door manufacture will determine the specification of fixings required to meet the test data.

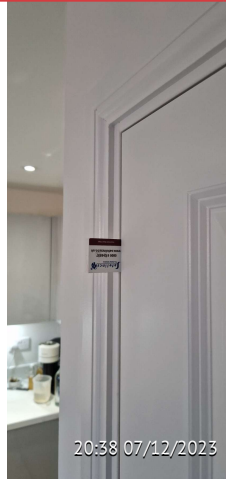
#### ISSUE 76

Door gaps to frame insufficient, 5mm gap present, tolerance is between 2mm and 4mm to be compliant. Adjustment required to ensure compliance.

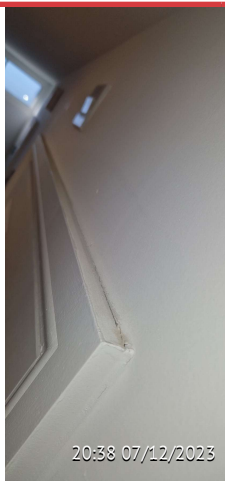
### ISSUE 83

Incomplete works : Architraves to all 3 door sets are not decorated. Decoration to be complete.

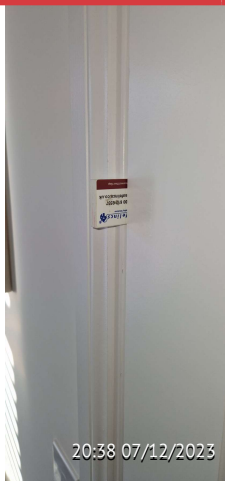
#### ISSUE 85

Door gaps excessive, adjustment required.

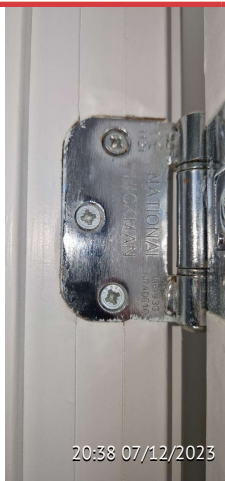
#### ISSUE 86

Fixings used on door hinge are not the correct fixings. Spax fixings used, fixings should be from hinge manufacture.

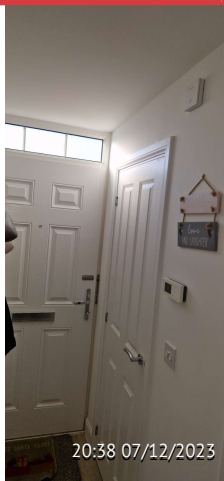
### ISSUE 91

Thermostat very close to the entrance door. Every time the door open the heating is starting. Developer to review.

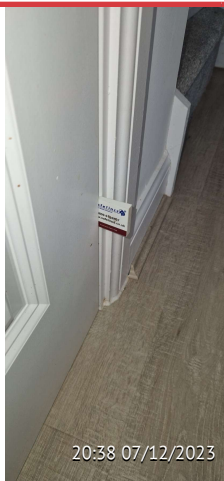
### ISSUE 92

Door gaps to frame are excessive, adjustment required.

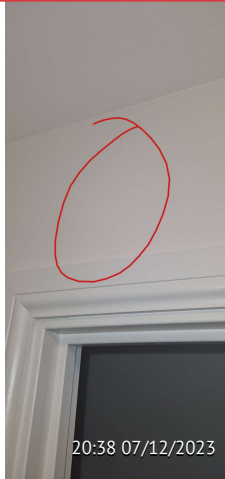
### ISSUE 93

Scrim tape visible through wall finish, improvement required.

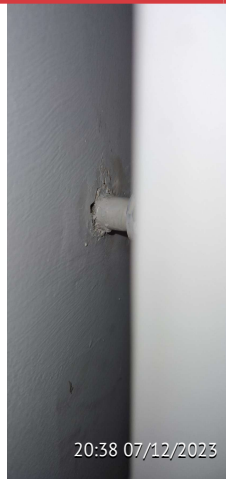
### ISSUE 96

Poor finish around domestic water pipes behind pedestal, improvement required.

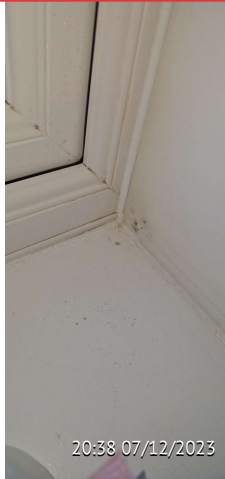
### **ISSUE 105**

Mould present to RHS at low level of right sided window.  
Developer to review urgently.

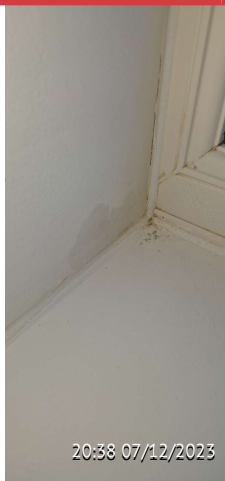
### **ISSUE 106**

Mould present on LHS of right window. Wall visable damp. Developer to review urgently.

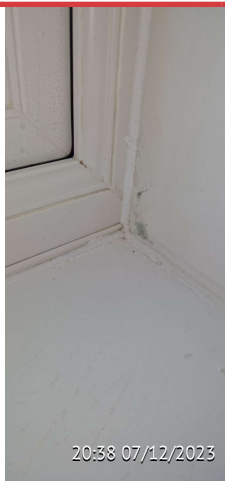
### **ISSUE 107**

Mould present on RHS of left window

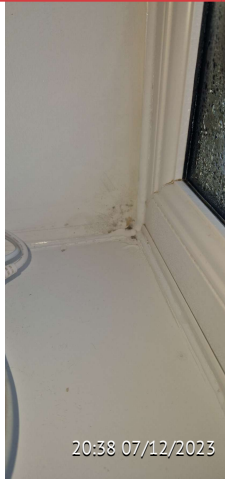
### ISSUE 108

Mould present LHS of right window and wall is visably damp. Developer to review urgently.

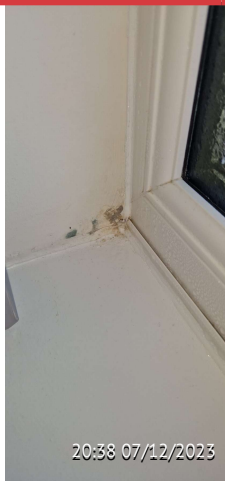
### ISSUE 109

Mould present on LHS of left window, developer to review urgently.

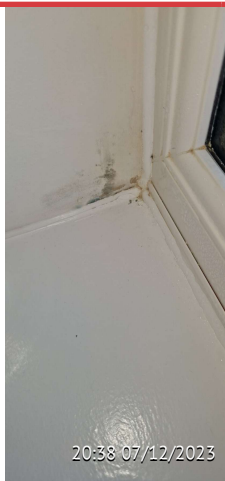
### ISSUE 110

Mould present on LHS of right window, developer to review urgently.

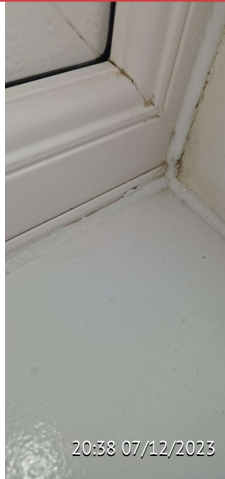
### ISSUE 111

Sealant failed RHS of right window at window board, reapplication required.

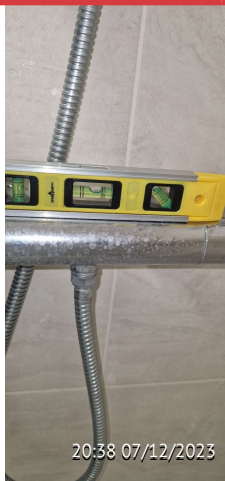
### ISSUE 118

Shower mixer, not level, adjustment required to ensure level.

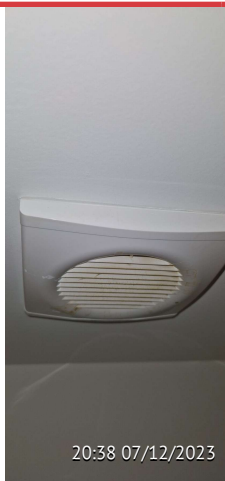
### ISSUE 119

Poord decorations to extractor fan

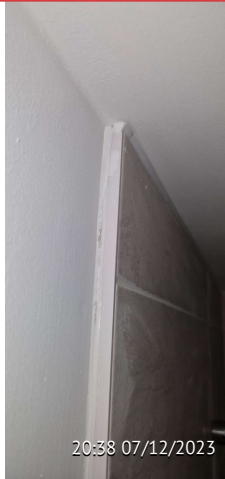
### ISSUE 120

Over spill of paint to be cleaned off at tile edge.

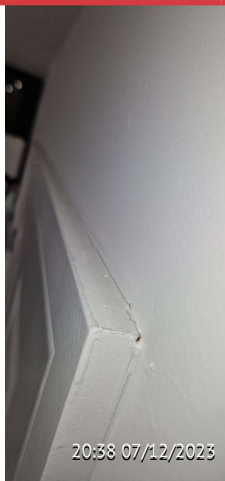
### ISSUE 124

Poor decoration to top of door architraves, improvement required.

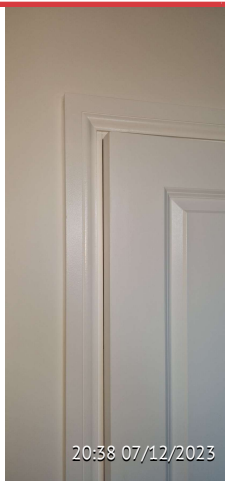
### ISSUE 125

The door is not closing. Clashing with door frame, adjustment required.

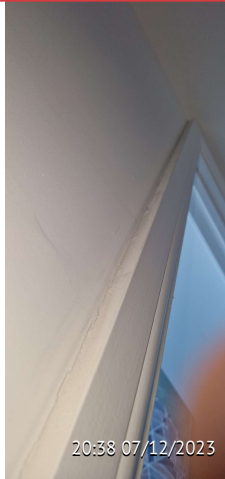
### ISSUE 126

Poor decoration to top of architrave on both sides, Improvement required.

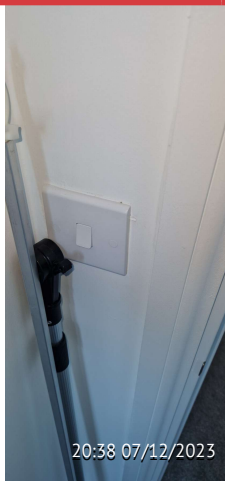
### ISSUE 127

Decoration to be improved around light switch

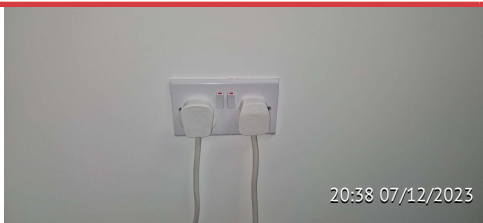
### ISSUE 128

Screw caps missing from double socket.

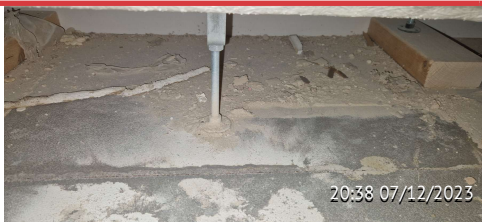
### ISSUE 133

No timber spreader under central leg of the bath. Timber spreader required to speed the load from the path into the joists below.

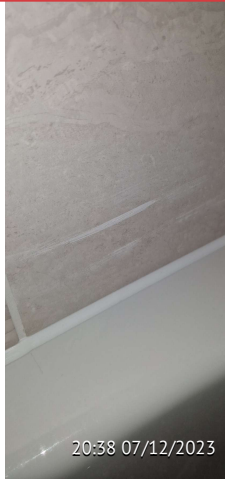
### **ISSUE 135**

Grout mark to be removed.

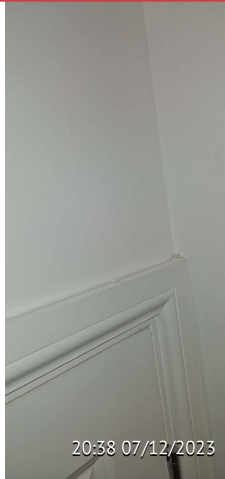
### ISSUE 138

Poor decorations to top of architrave, improvement required.

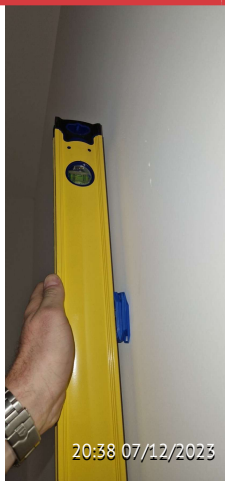
### ISSUE 139

Wall lining out of plumb by 15mm. Developer to review with client to agree on remedial action.

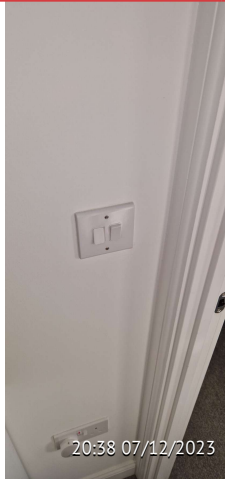
### ISSUE 141

Light switch seems to be not as specification as all other switches in the property. Replacement required for consistency.
